Engineering Geomorphological Assessment and Slope Hazard Identification of the Haast Pass Highway Corridor

State Highway Six, Haast Pass, New Zealand

Master of Science in Engineering Geology

by
Andrew Timothy Walsh
2015

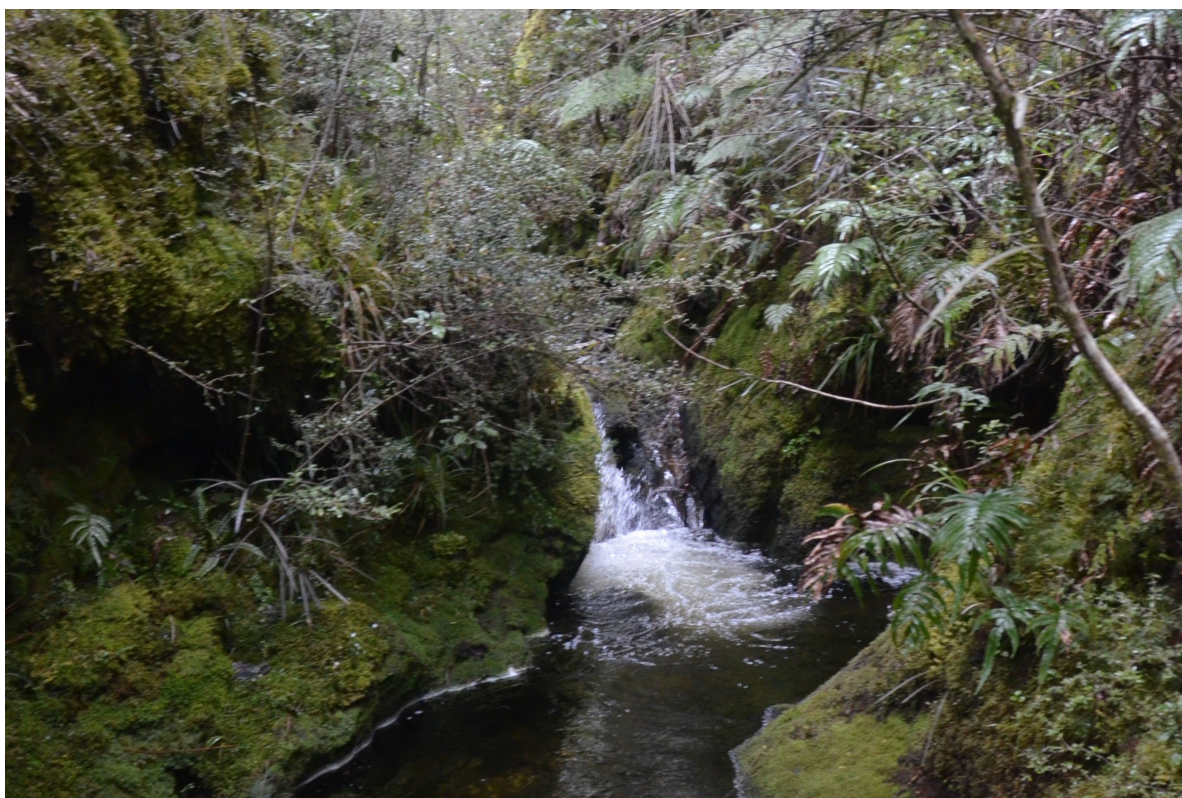
Figure 3.4: SITE 1a. Stream flowing in a steep sided channel. Schist bedrock is exposed in the stream bed and on the steep sided margins where it is covered by moss. The regolith material begins where the vegetation overhangs the stream above the moss. The location of this site is shown in Figure 3.3 (S1)

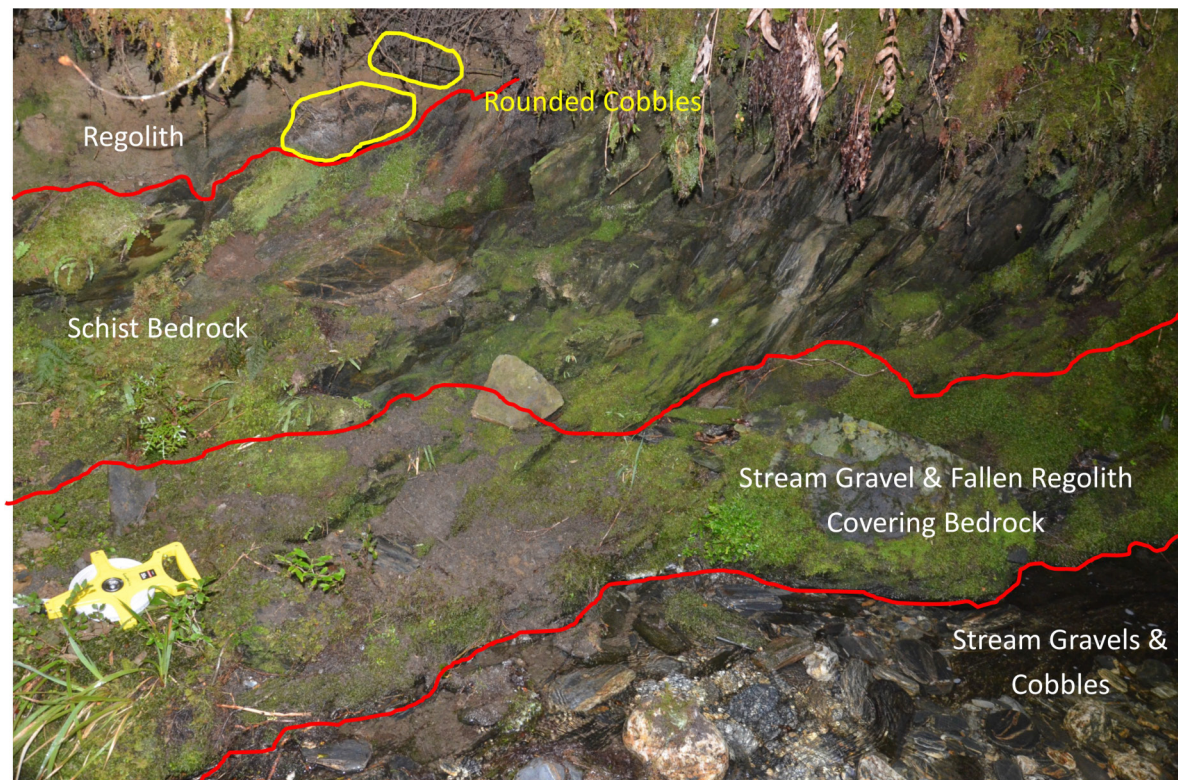
Figure 3.5: SITE 1b. The regolith bedrock contact can be seen at the top of the image. The regolith material consists of coarse sand and rounded gravel with rounded cobbles of schist (Yellow annotation) with a light brown appearance. The regolith sits over schist rock with foliation orientations matching regional bedrock attitudes. The location of this site is shown in Figure 3.3 (S1)

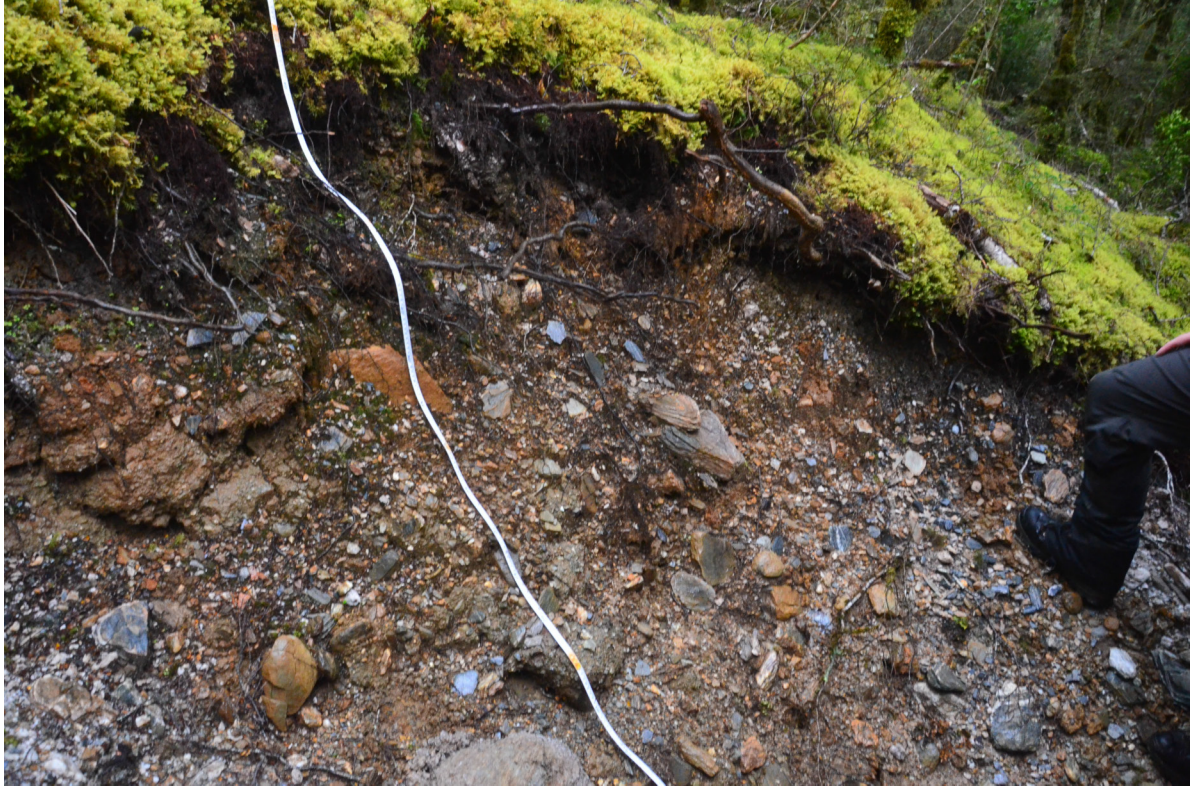
Figure 3.6: SITE 2. Exposure of regolith beneath an overturned tree (Behind photographer). Material consists of angular gravels and cobbles of schist rock. The location of this site is shown in Figure 3.3 (S2)

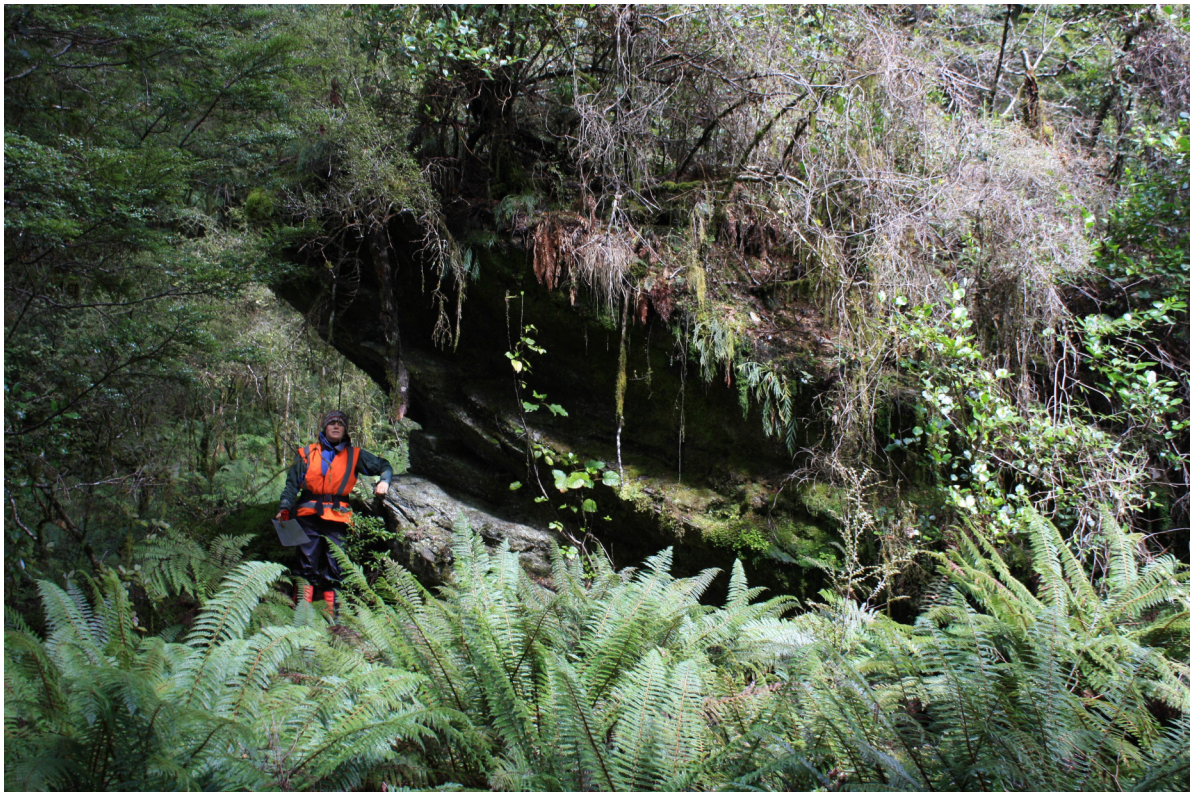
Figure 3.7: SITE 3. Schist boulder at the base of a regolith covered slope next to the highway. Many boulders such as this one are present at this location with a wide range of foliation attitudes inconsistent with regional bedrock. The location of this site is shown in Figure 3.3 (S3)

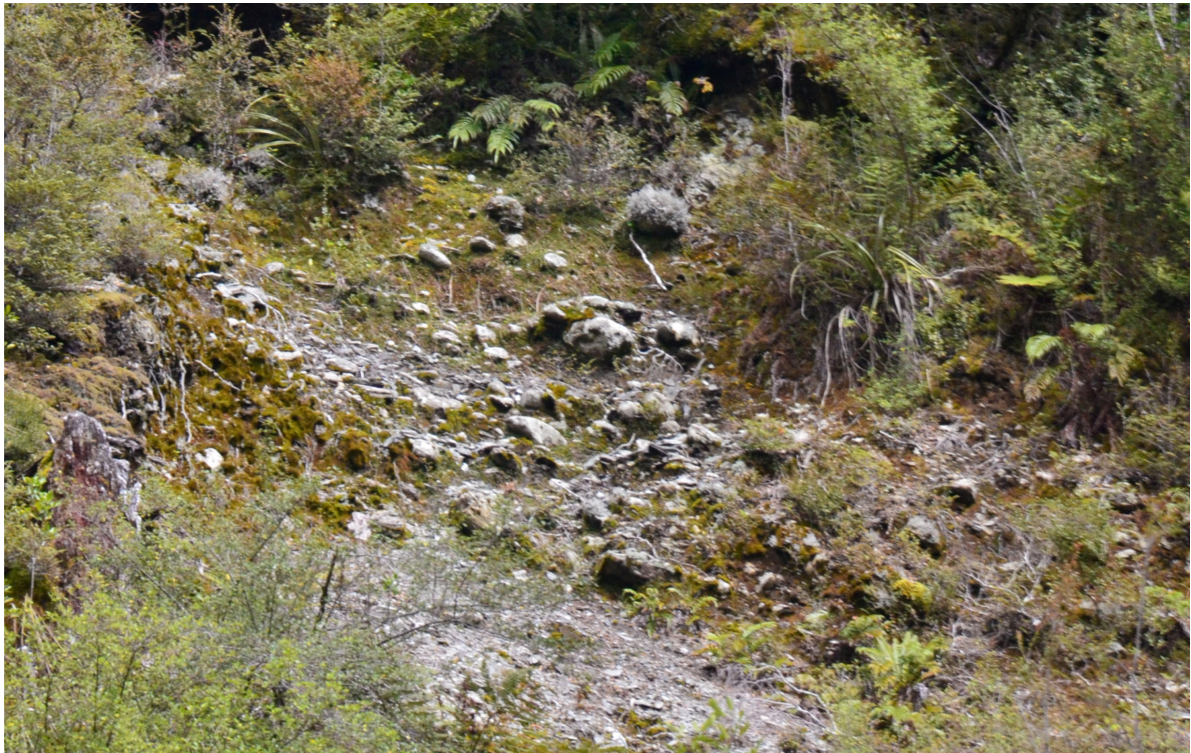
Figure 3.11: SITE One. Rounded clasts exposed on the side of a planar smooth surface identified in the LiDAR analysis. The material is inferred to be part of a river terrace with evidence that the terrace surface extends across lower parts of the slope (Figure 3.10 D).

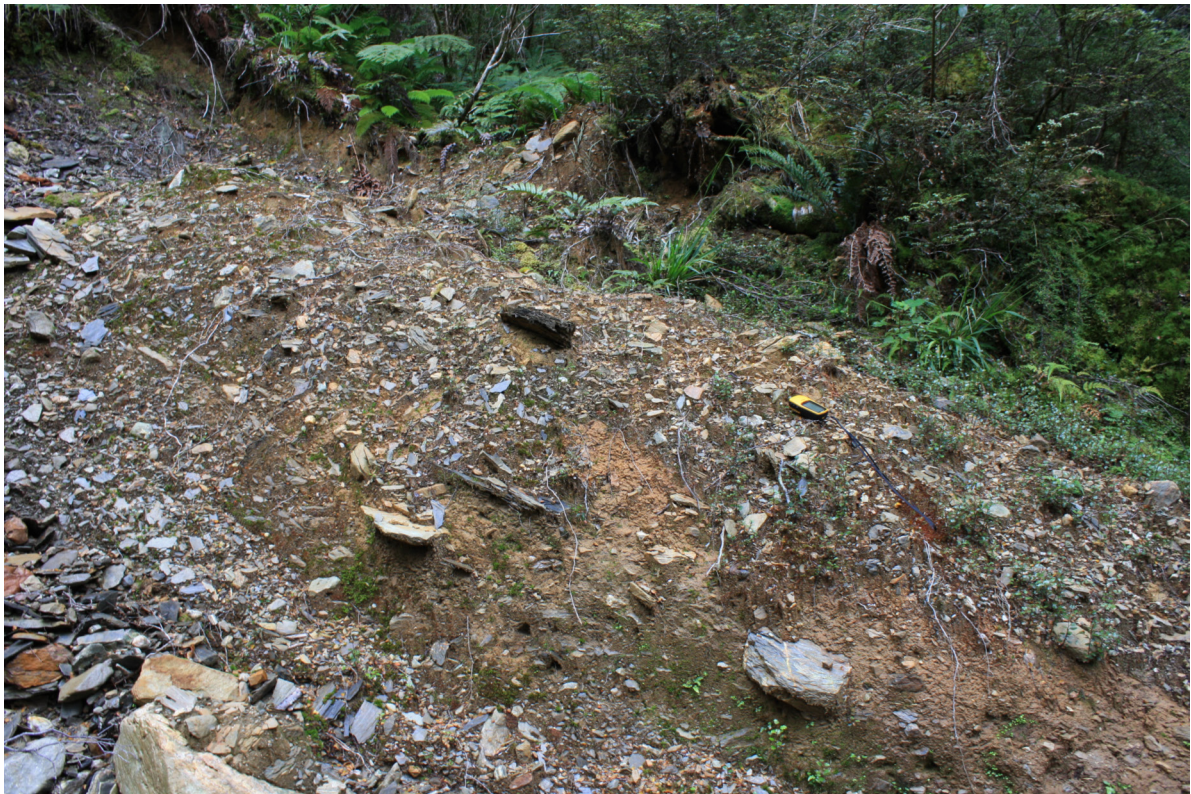
Figure 3.12: SITE Two. Colluvium exposed on a steep slope next to the highway north of Robinson Creek (Figure 3.10 S3). The material exposed consists of angular coarse gravels, cobbles and small boulders set in a fine matrix of coarse sand (NZGS Classification). The material is likely a mix of regolith from the slopes above and fresh clasts of schist rock from the bedrock outcrops at the top of this small slope.

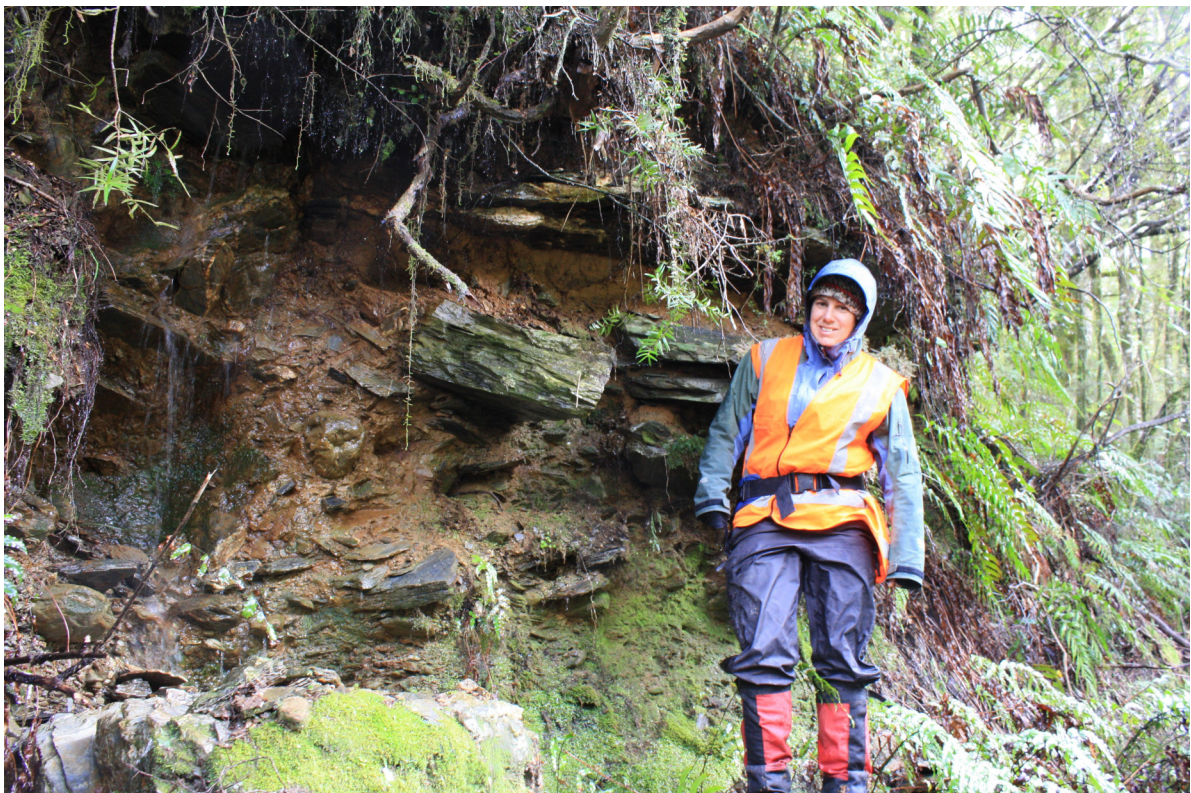
Figure 3.16: Site One. Exposure of material at the base of a large regolith deposit. The materials exposed consist of schist rock that are very angular and platey in shape as a result of the foliation in the schist. The matrix material consists mostly of angular gravels of schist rock with very minor amounts coarse sand and is non cohesive (NZGS Classification)

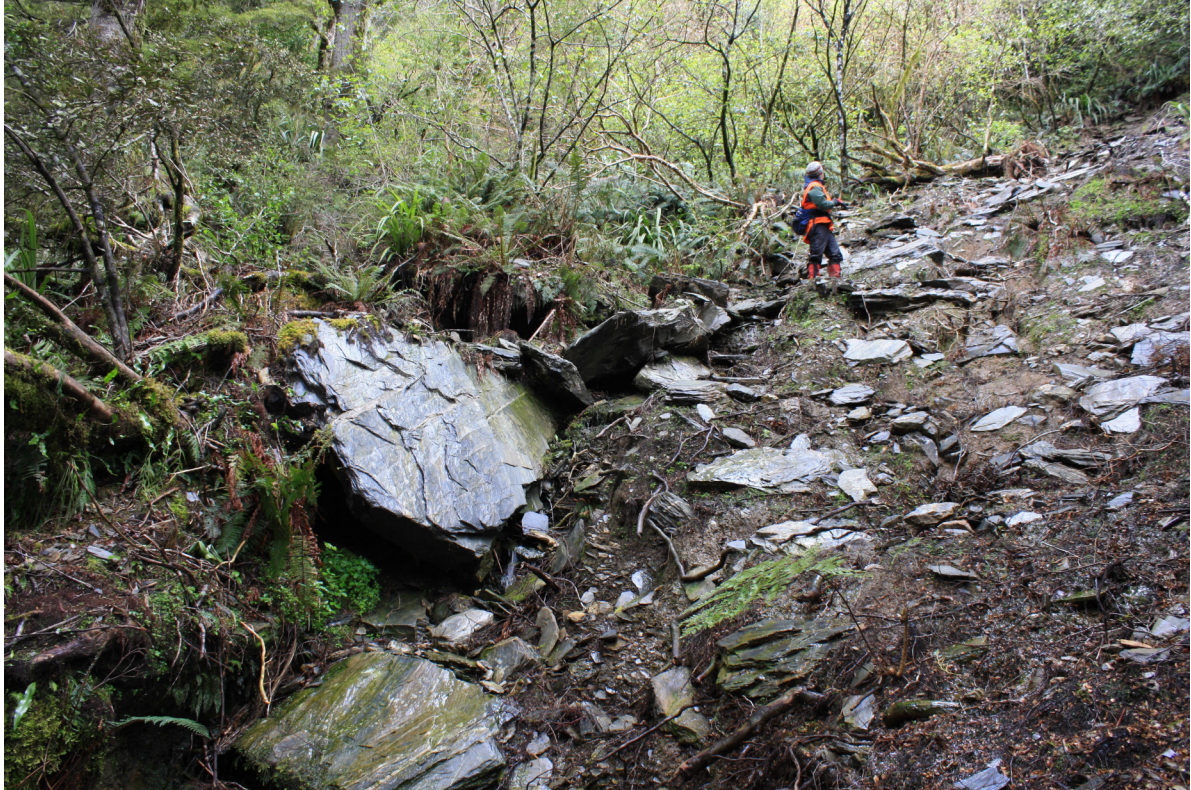
Figure 3.17: Site Two. Exposure of material on a regolith slope looking up slope towards large cliffs that are not visible in the image. The material exposed consists of large boulders, cobbles and coarse gravels that appear angular in appearance with a matrix consisting of fine gravel and coarse sand that is non cohesive (NZGS Classification).

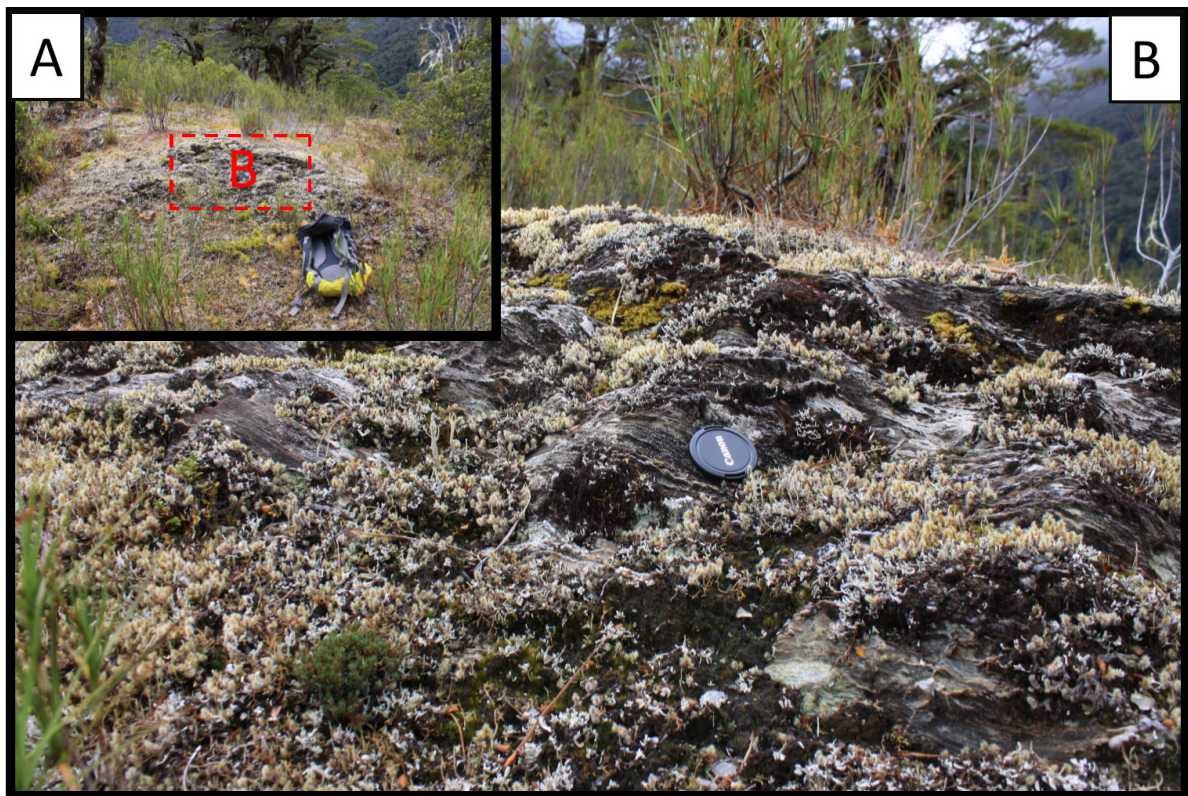
Figure 3.18: Site Three. (A) Area of sparse vegetation identified in the aerial photography as an area light brown in colour. The light brown colour is a result of the lack of vegetation and the moss covering this area. The dark area highlighted by the red dashed area is the location of the image in part B. (B) Schist foliation structures are visible as the subtle white lineations running across the image. Measurements of these structures reveal that the orientation matches that of bedrock indicating the exposure is in-situ bedrock.

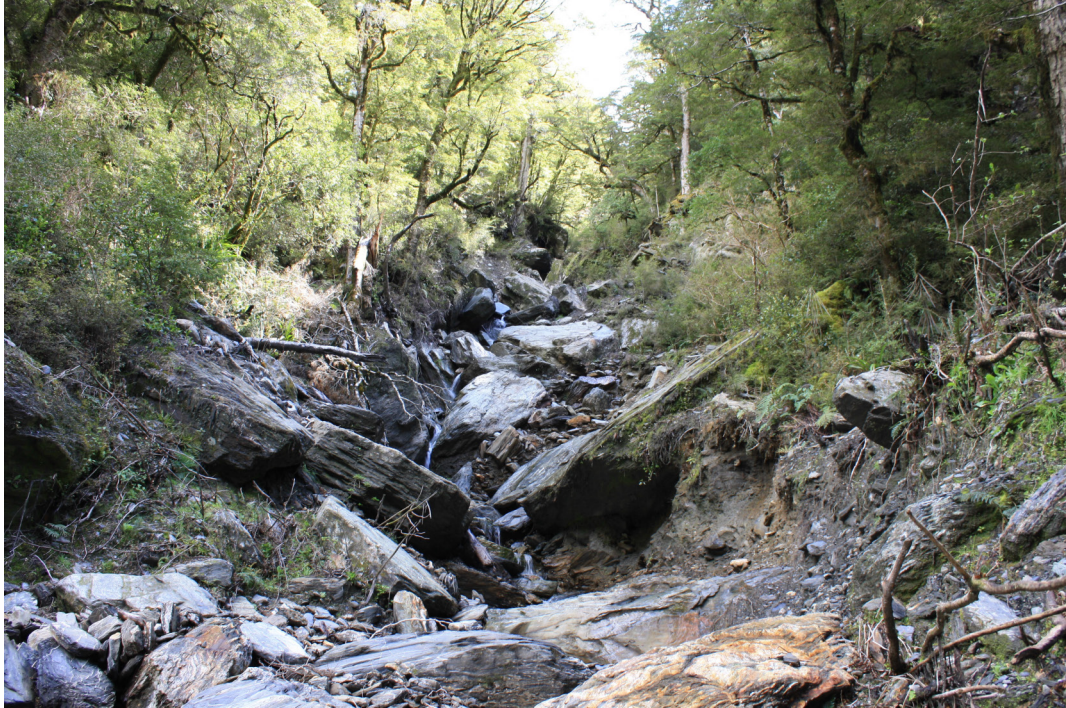
Figure 4.4: SITE 1a. View of the Pipson Creek channel looking upstream from a location 20 metres from the highway. Large angular schist boulders are visible in the main channel as well as in the banks. The finer material between the large boulders consists of smaller boulders up to one metre across, Cobbles and a range of gravel sized particles (NZGS Classification).

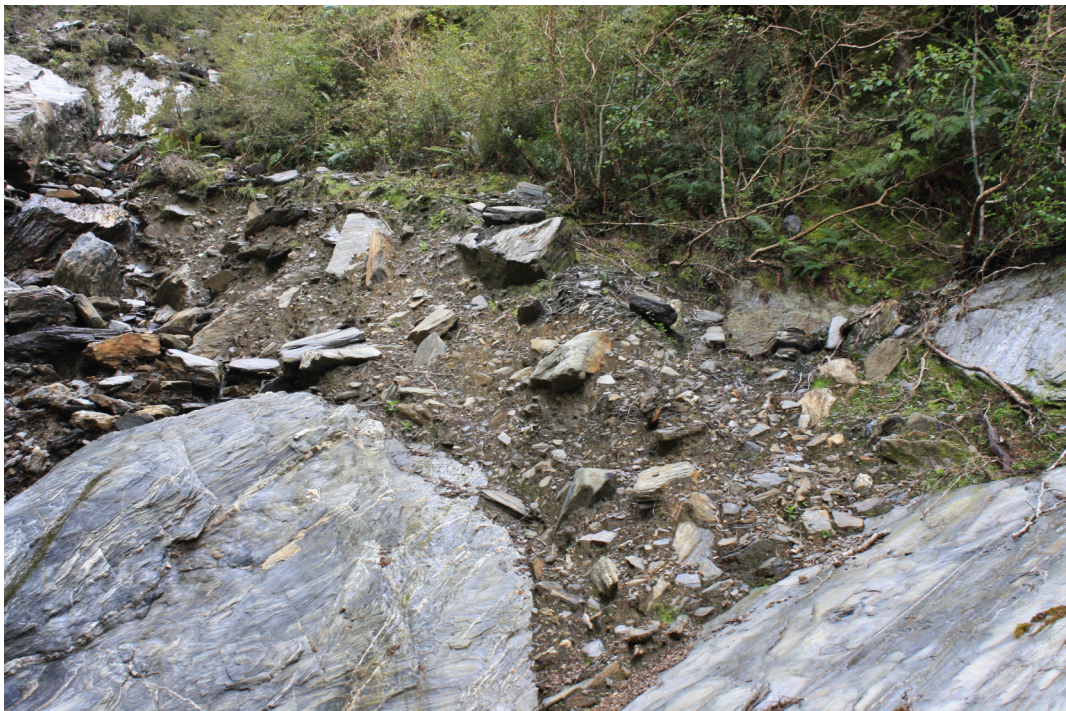
Figure 4.5: SITE 1b. This image is also taken at Site One and shows an exposure of the fine material found beneath boulders in the rest of the creek. The two areas of schist rock at the bottom of the image are part of large schist boulders with the material on top consisting of angular clasts of smaller boulders, cobbles and a range of gravel sized particles (NZGS Classification).

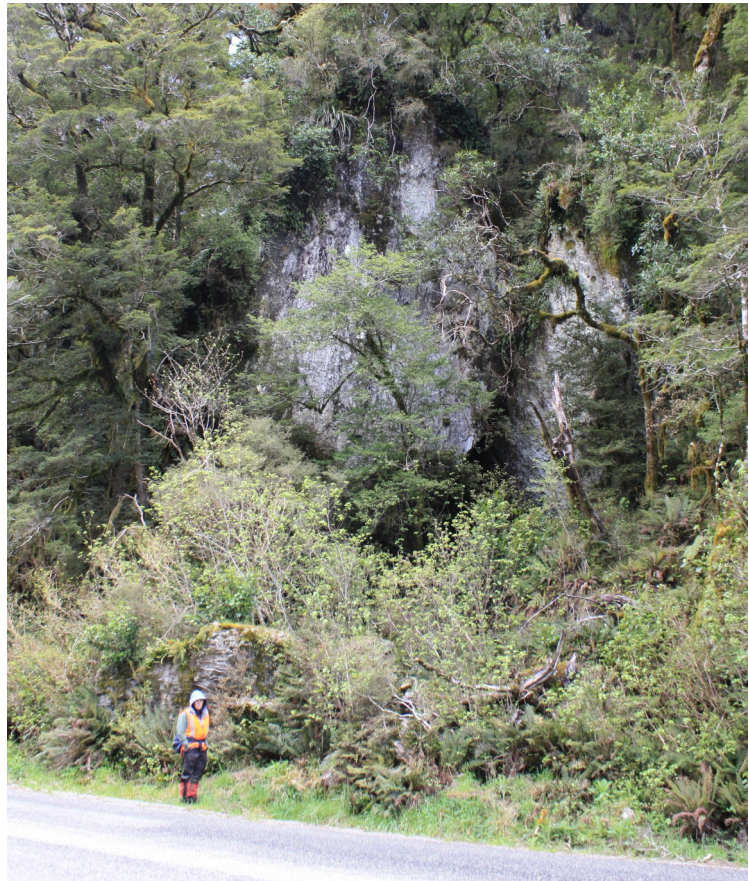
Figure 4.6: SITE 2a. Photo of the Pipson Creek debris fan looking up slope from the highway 50 metres north of Pipson Creek. Three large schist boulders are visible. The first at the bottom of the image is approximately three metres wide and has horizontal foliation orientations. The second and third boulders are visible in the trees in the centre of the image surrounded by vegetation. Foliation orientations of these boulders are variable and do not match regional bedrock orientation indicating that they have moved in the past.

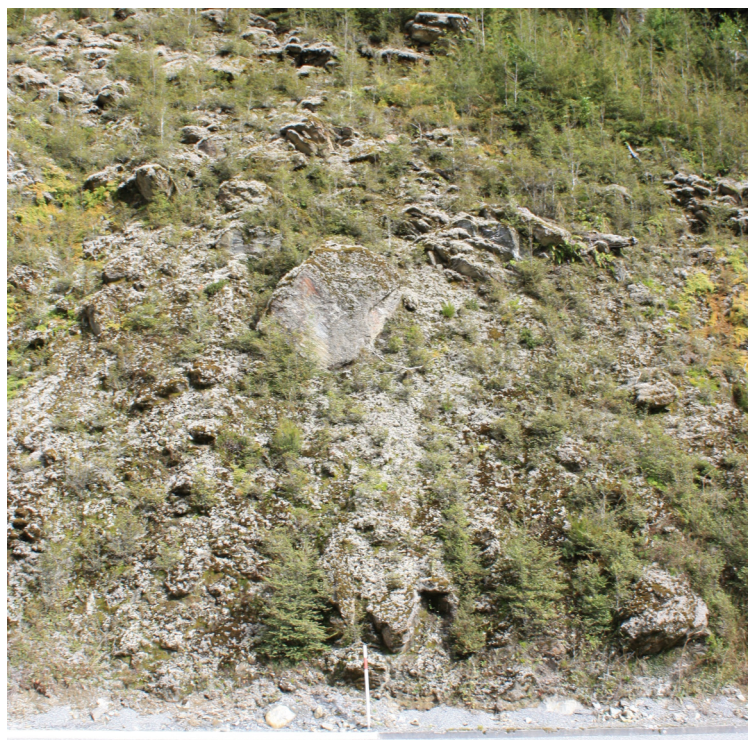
Figure 4.7: SITE 2b. Exposure of debris fan material 100 metres north of Pipson Creek where the highway has been cut into the slope 50 metres above the Haast River. The material consists of boulders, cobbles and gravel all angular in appearance with a wide range of foliation orientations (NZGS Classification). The road marker for scale and is one metre high.

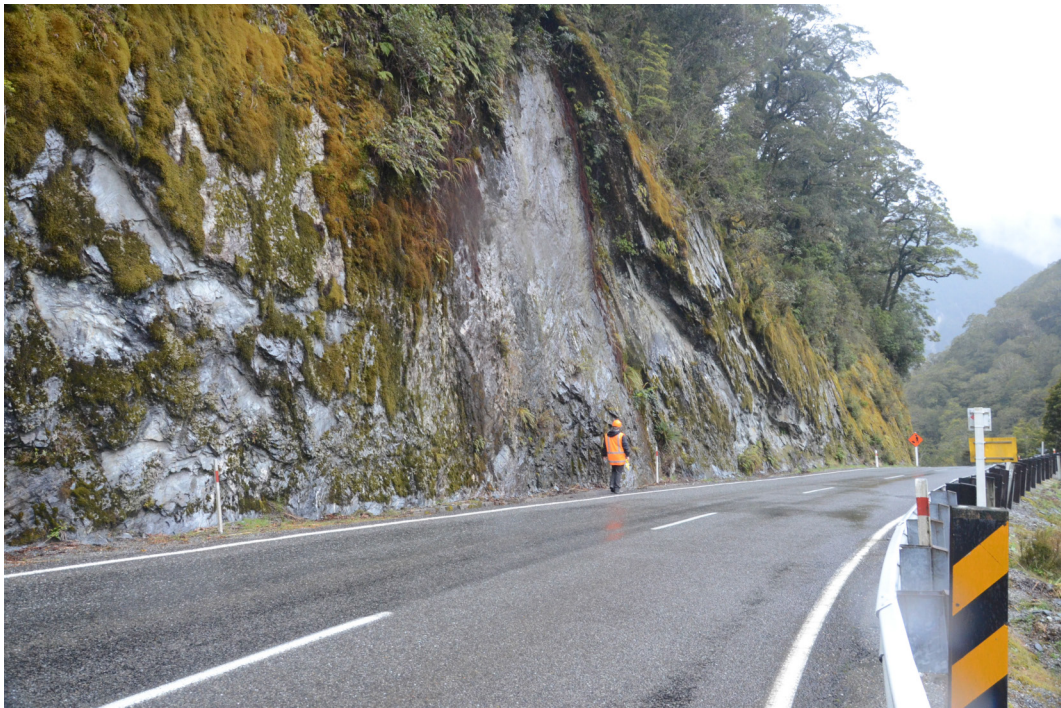
Figure 4.8: SITE 3. Vertical cliff of schist rock next to the highway. Rockmass defects measured from this rockmass indicated only two persistent defects. The first persistent defect is schist foliation, visible as the face of the cliff, dipping between 70 and 80 degrees to the east and striking 000 to 010 degrees indicating that the schist cliff is an exposure of bedrock. The second defect consists of a joint set, visible as the lineations running across the cliff, dipping approximately 30 degrees to the east and striking approximately 100 degrees. The person in the image is 175cm tall for scale.

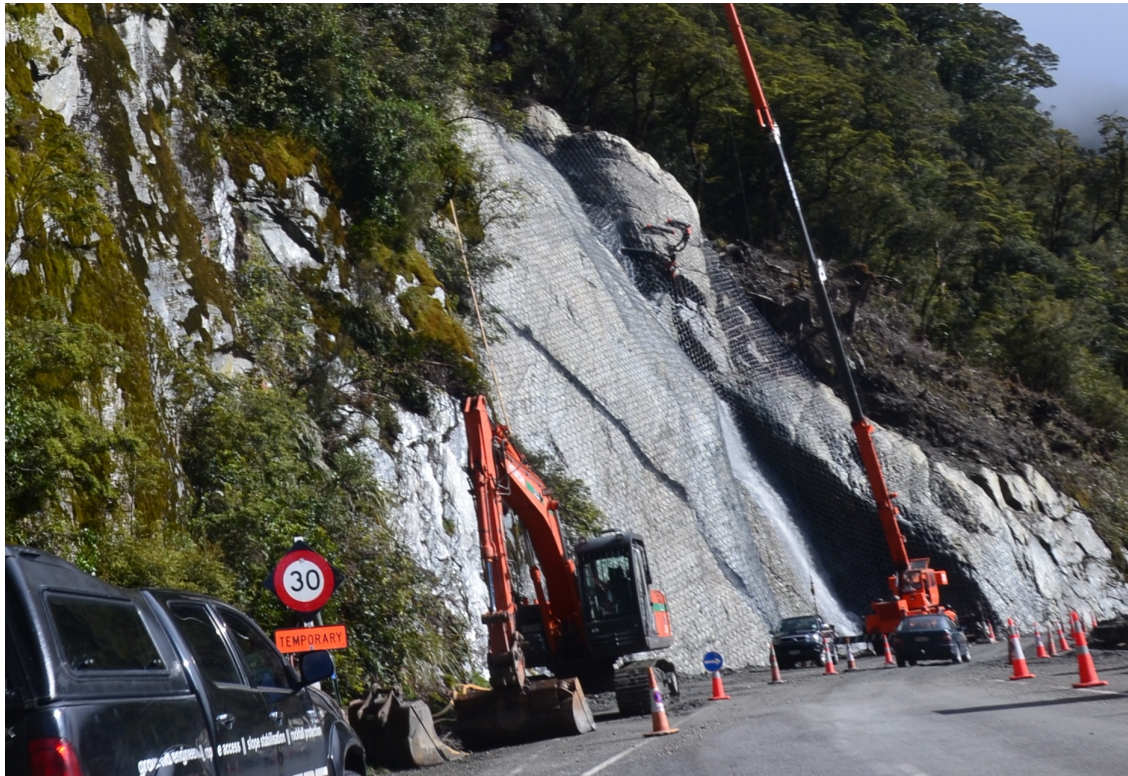
Figure 4.9: SITE 4. Photo taken looking north towards the bottom of the Diana Falls landslide. The cliff next to the highway has foliation orientations matching that of schist bedrock and lacks many other defects with only one visible as the diagonal line running across the face. Note the darker material behind the orange crane that is a mix of vegetation and regolith that is typical of the material observed above many of the cliffs next to the highway.

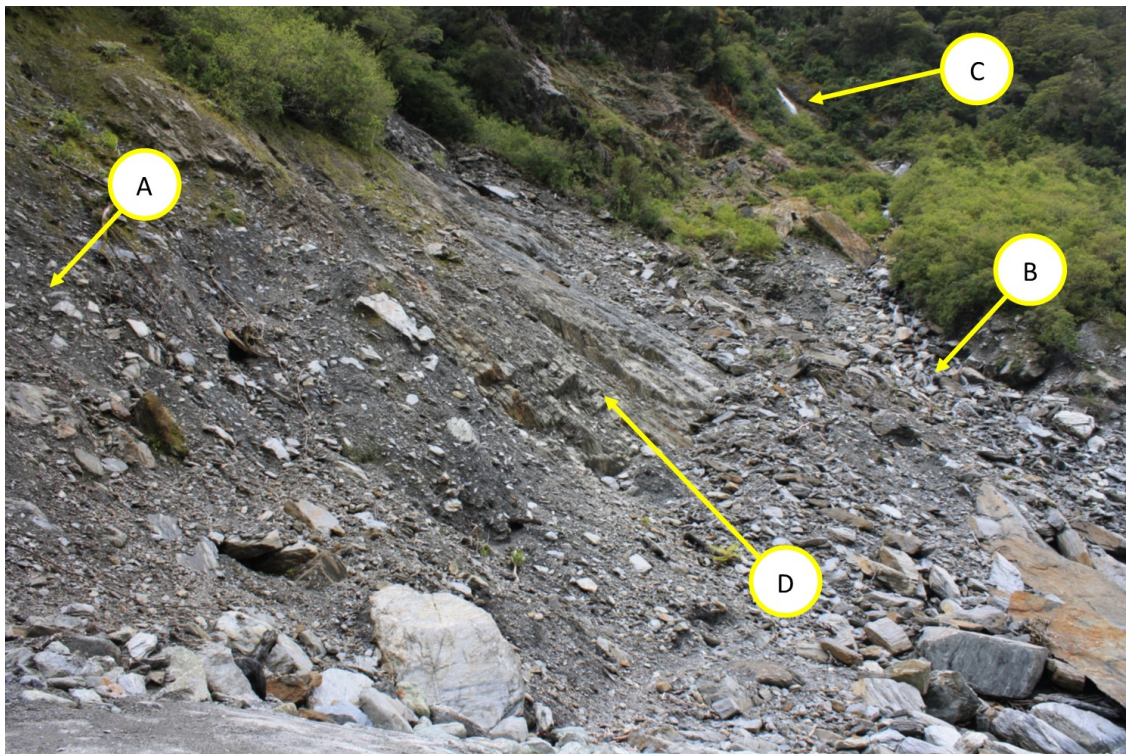
Figure 4.14: SITE 1. Regolith exposure on true right slope upstream of the Gates of Haast Bridge. A) Exposure of older regolith material above the river. B) fresh regolith material deposited by the stream is the back of the Image(C). D) Exposure of schist bedrock within the largely regolith covered slope. Foliation orientations closely match that of regional schist bedrock.

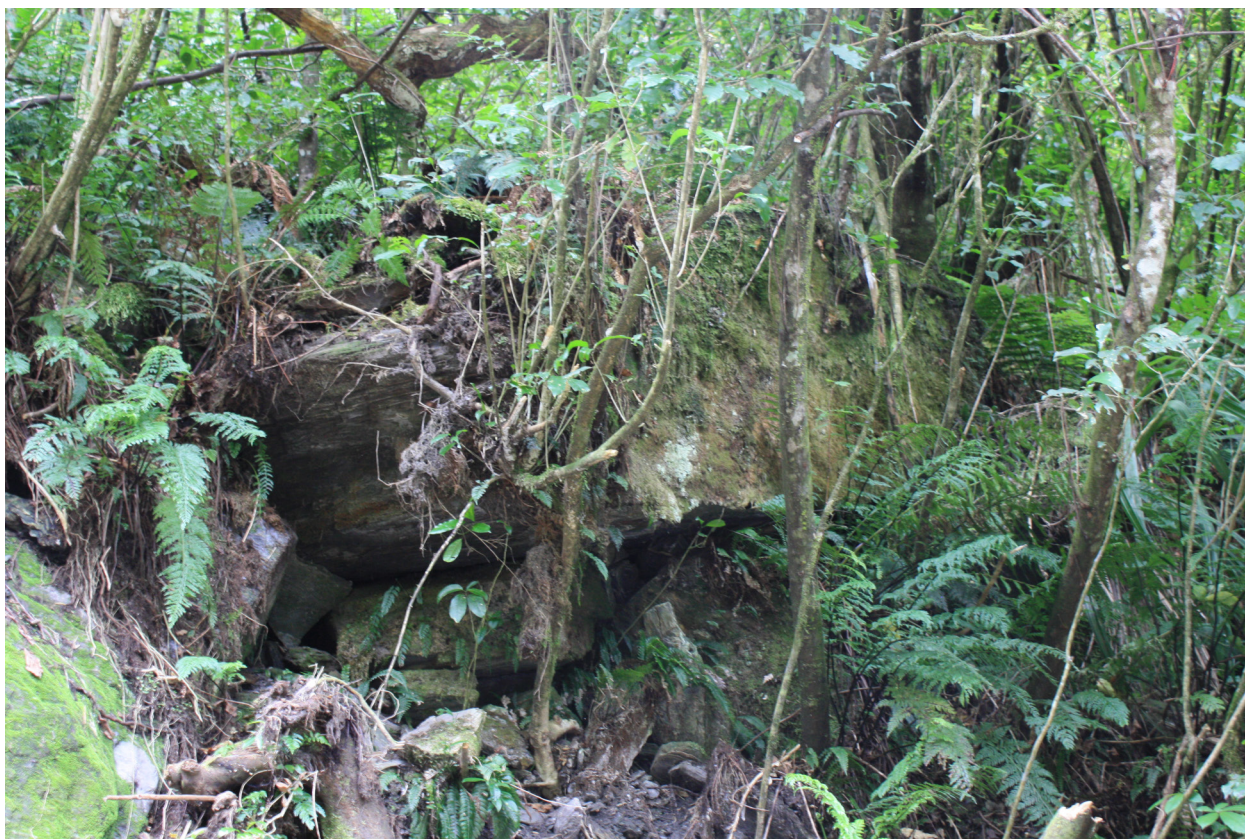
Figure 4.15: SITE 2a. Schist boulder approximately 2x3 metres across on the drainage track above the Gates of Haast Bridge.

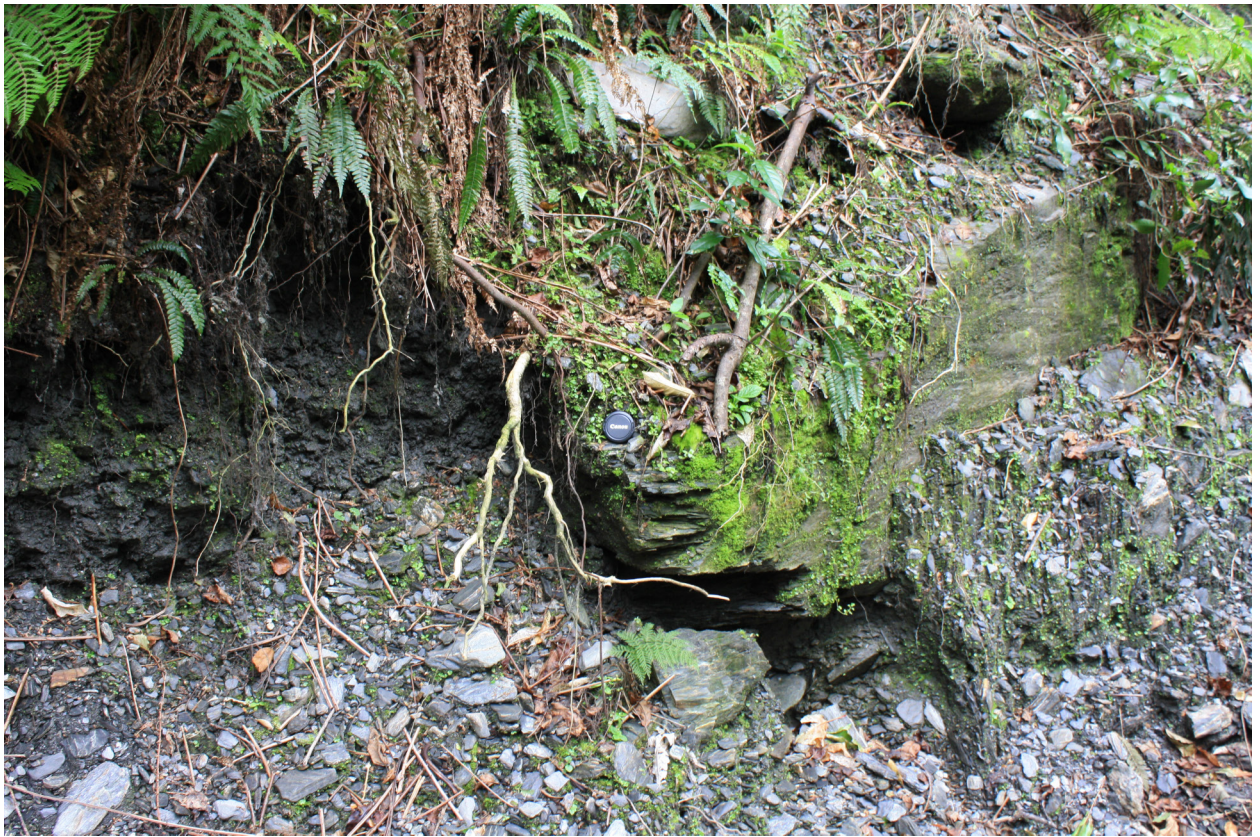
Figure 4.16: SITE 2b. Regolith matrix material on the drainage track above the Gates of Haast Bridge

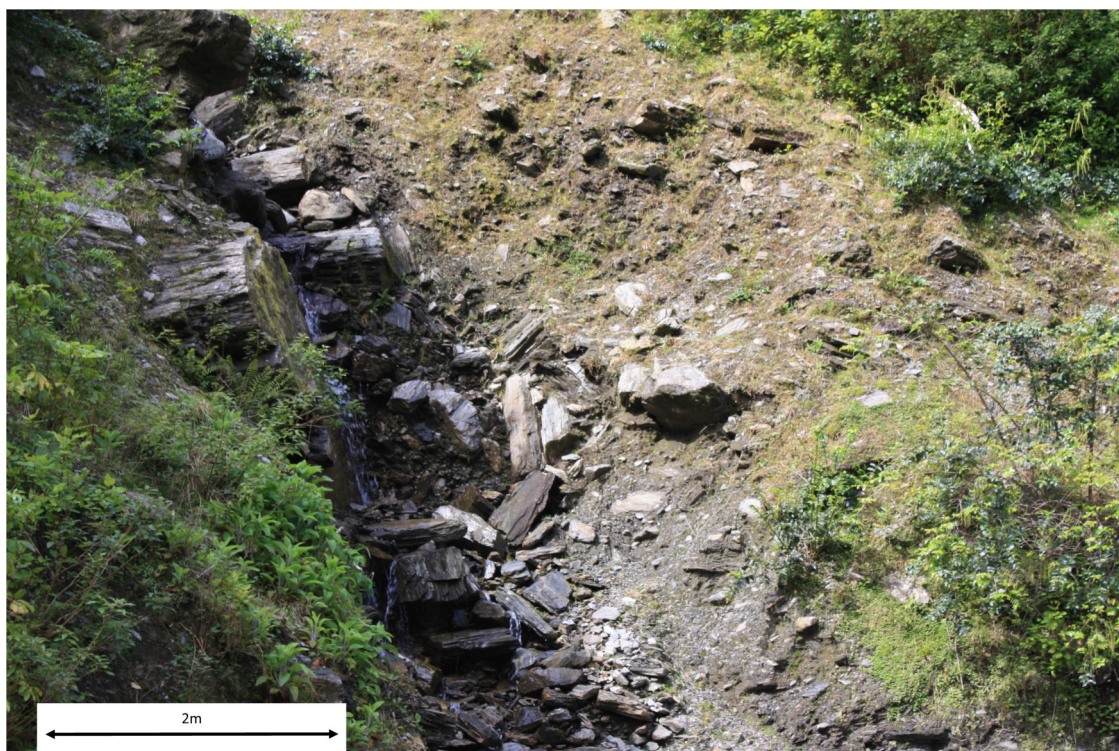
Figure 4.17: SITE 3. Exposure of regolith material in stream west of Gates of Haast Bridge.

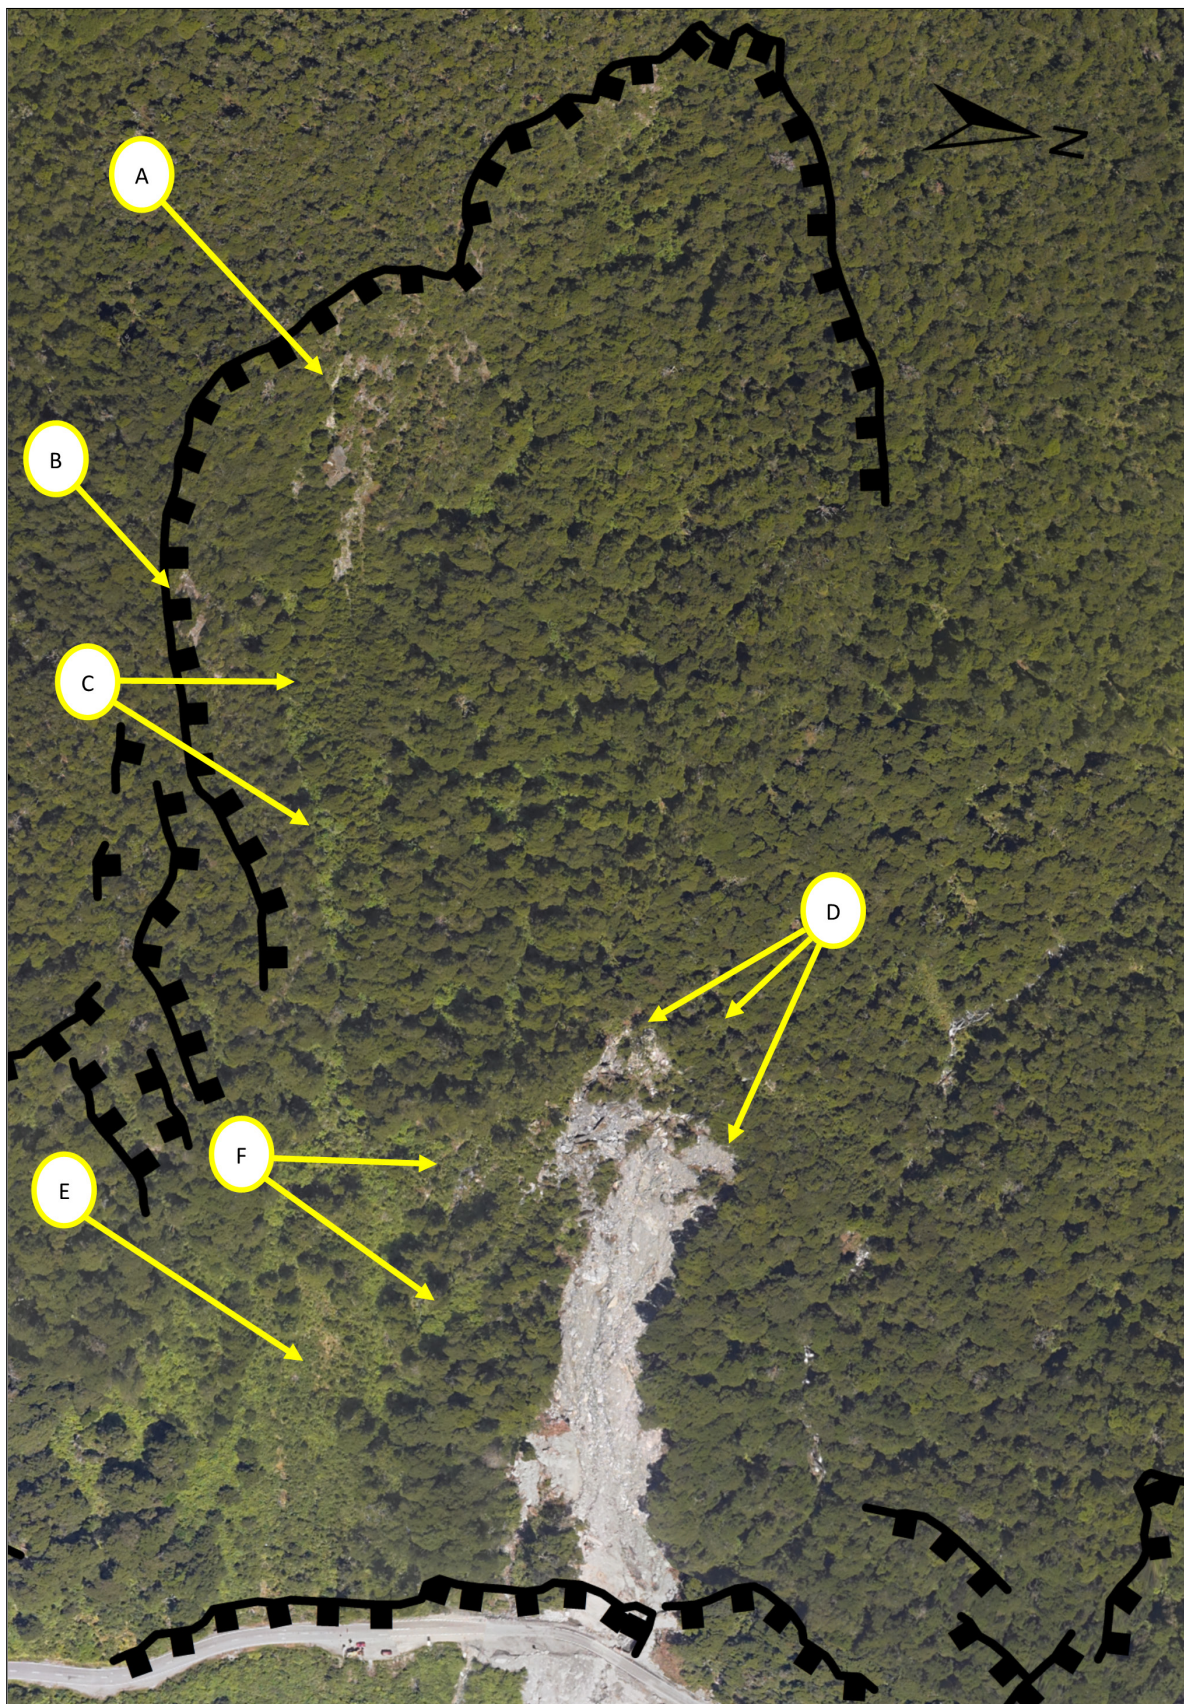
Figure 5.5: Aerial photo of the lower section of the Diana Falls landslide complex. The 2013 Diana Falls debris slide is clearly visible as the grey material extending above and below the highway. Large schist boulders are visible at the headscarp and measure up to 10m across.

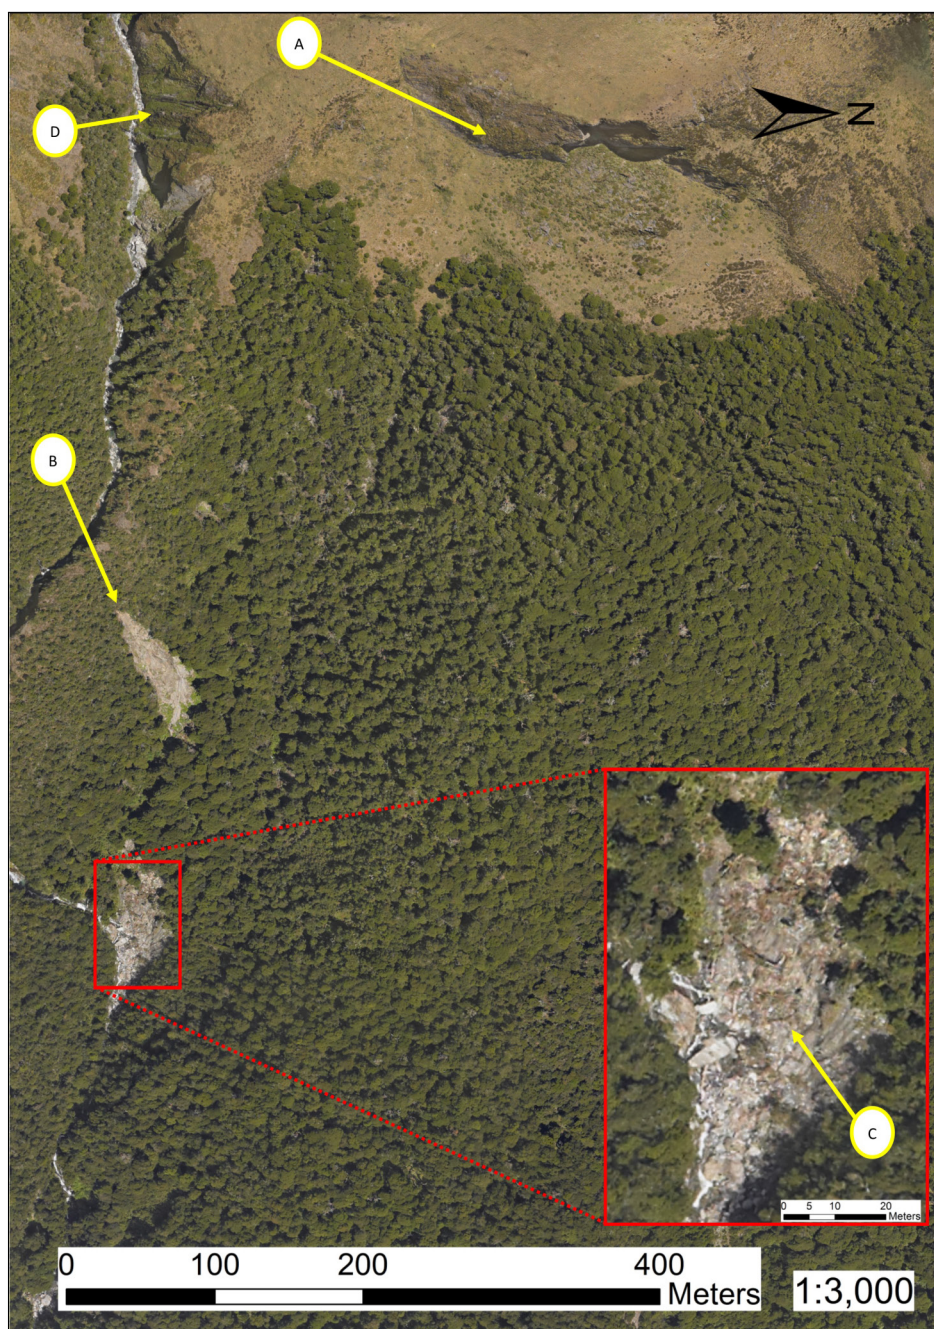
Figure 5.9: Aerial photo of the Ford Creek Landslide. A= Headscarp of the Ford Creek Landslide. B= Recent rockfall/rockslide from the side of a gully. C= Regolith materials exposed at the base of a gully by debris sliding action. D= Foliation lineations visible as well as another slope parallel defect set 20m east in the shaded region.
